CAPSULE SUMMARY
BA-2372
Blacksmith's House
10113 Falls Road
Baltimore, Baltimore County
Ca. 1877
Private

## Maryland Historical Trust Maryland Inventory of Historic Properties Form

The Blacksmith's House, Rockland, Brooklandville, Maryland

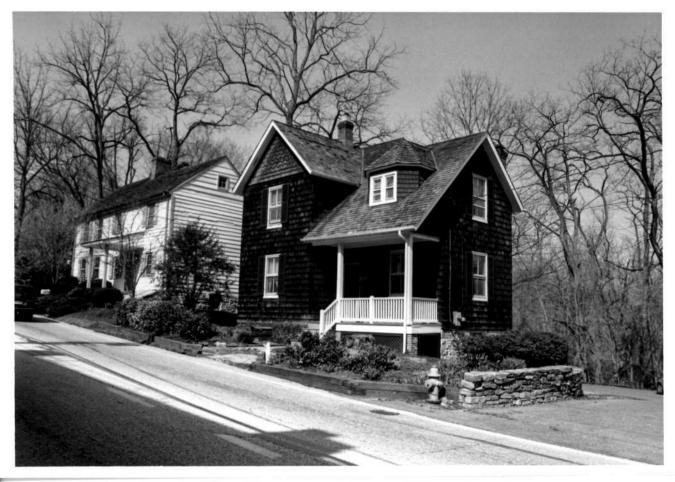
BA-2372

SOUTHWEST CORNER

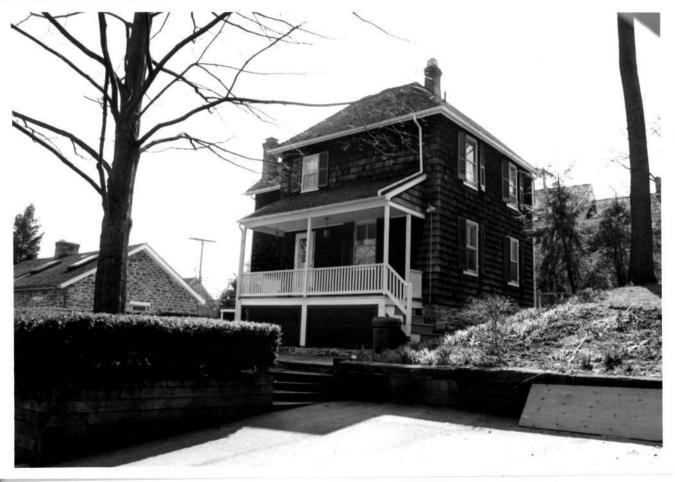
BA-2372 10113 FALLS ROAD BALTIMORE COUNTY, ND TRACERIES APRIL 2001 MD SHPO NORTHEAST CORNER 2 OF 2

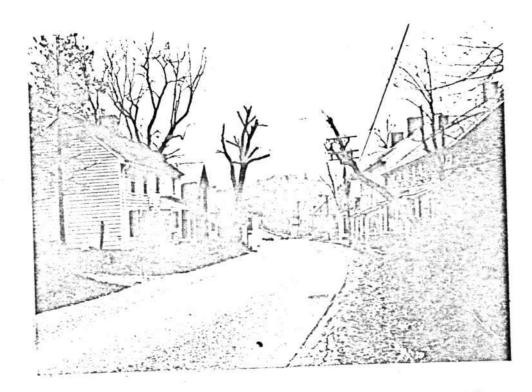
Blacksmith House, from the North, looking South along Falls Road.

The dark sningled Blacksmith's house can be seen on the left of the photograph, south of the "log House" Note the way the building fills in the road frontage between the log house and the blacksmith's shop, barely seen to the south of the subject property. Note the impact of the gable roof on the northern half of the Blacksmith's house, relating to the northern half of the log house (a 90° shift). The same relationship exists on the right side of the road with the stone row gable to the north of the 90° shifted general store gable. (seen in photo above.)

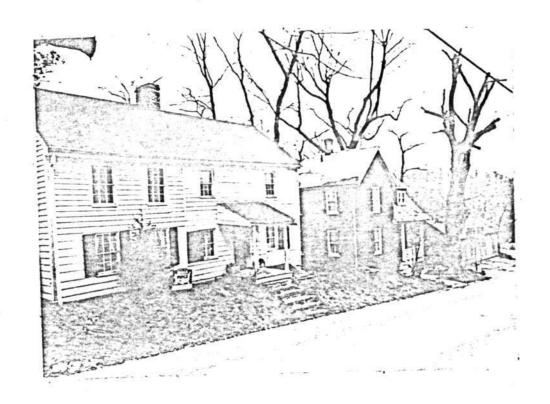
Blacksmith's House looking from the Northwest.

The fronts of the houses line up along the road edge. Note that the site sketch in the National Register submission inaccurately shows this house out of line with its neighbors. This is not the case. The site slopes down between the log house and the blacksmith's shop. The roof lines of the house help emphasize this stepping with the south gable parallel and the north gable perpendicular to the shed of the shop below.
